Silicon Precipitate Nodule-Induced Failures of MOSFETs

M. Johnson and D. Pote
Motorola, Inc.
Northbrook, IL

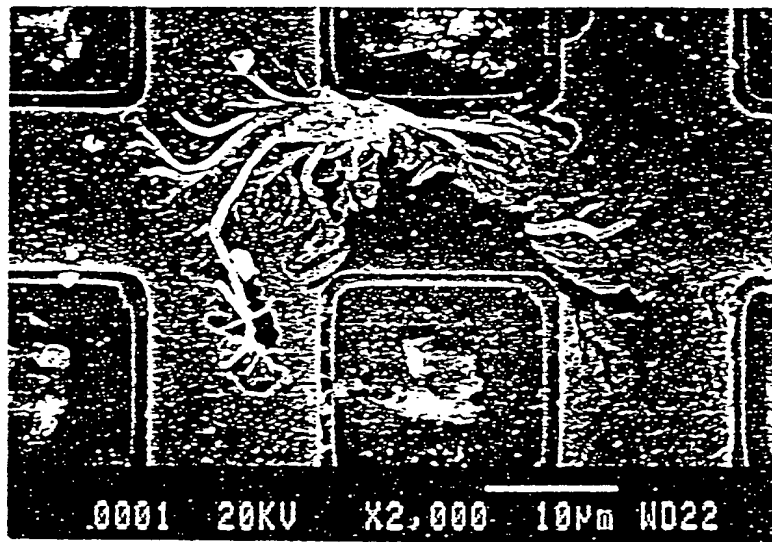
Figure 1: Unique pattern of fused polysilicon observed after removal of metallization and insulating oxide. (2000X)

Subsequent optical inspection identified an apparent electrical damage site under the wirebond. This damage was characterized by a central fused-site surrounded by multiple filaments (Figure 1). These filaments were dubbed "tentacles" or "roadkill" damage because of their appearance. SEM inspection of the same locations revealed surprisingly little

It is now believed that the filaments are the result of amplification of the damage at the original failure sites by the application of excess power during liquid crystal testing. A slightly higher level of power was necessary to counteract the obstructing heatsink effect of the relatively large wirebond. The heat generated at the damage site would initiate crystallization of the amorphous polysilicon depend-

ing on the amount of power dissipated. If the applied power during LC testing was maintained at 25 mW or less, little or no filament growth would occur. Deliberate "decoration" of the damage site by generating filamentation was a useful albeit destructive technique to simply confirm the presence of this failure mechanism since it requires only a readily available medium power optical microscope to locate the damage site.

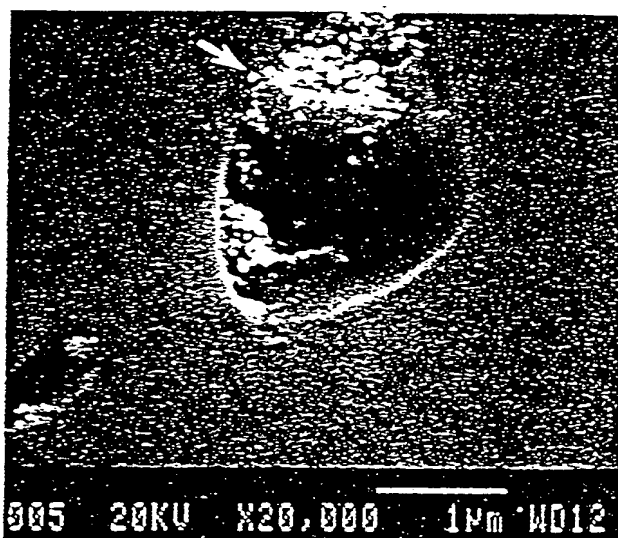
Figure 2: Small electrical damage site within chip.
(25000X)

Cross-sections of failures revealed that the filaments were confined to the polysilicon layer, except at the central nucleus. At the nucleus, melted silicon and aluminum were observed extending vertically through the dielectric layer. On several devices where the filamentation was minimal, there was limited evidence of melting at the nucleus site and a small section or chip of the dielectric was missing (figure 2).

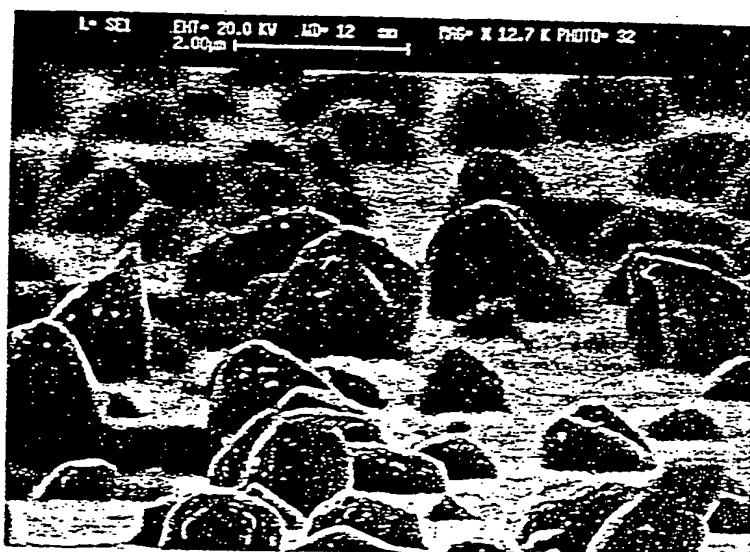
shape. Although they appear roughly circular under high power microscopy (400X), they are actually polyhedral and exhibit a wide range of aspect ratios (Figure 3). Typical height/width ratios range from 0.3 to 1.8.

Figure 3: Silicon precipitates (nodules) viewed from side exhibit variety of shapes and sizes. (12700X)

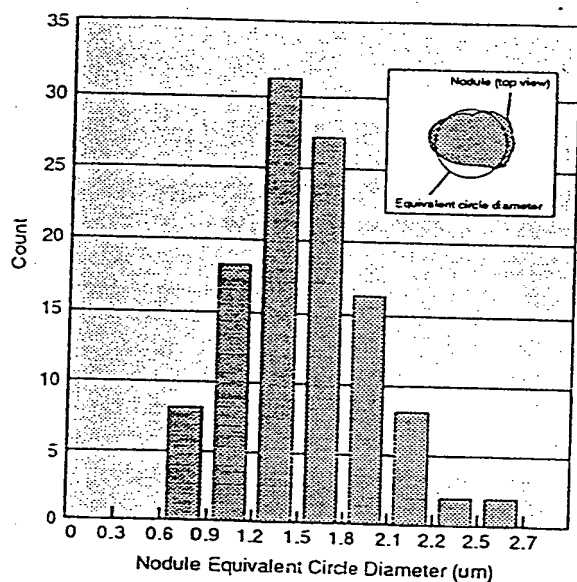
There were typically 50×10^3 to 100×10^3 nodules per square millimeter in the subject devices. In general, the nodule density -- the number of nodules per unit surface area -- was inversely proportionate to the average size of the nodules. That is, when the nodules were large, there tended to be few of them. Conversely, when the nodule count was high, they tended to be small. Figure 4 shows a typical histogram of nodule sizes produced by an image analysis

Figure 4: Example distribution of nodule sizes

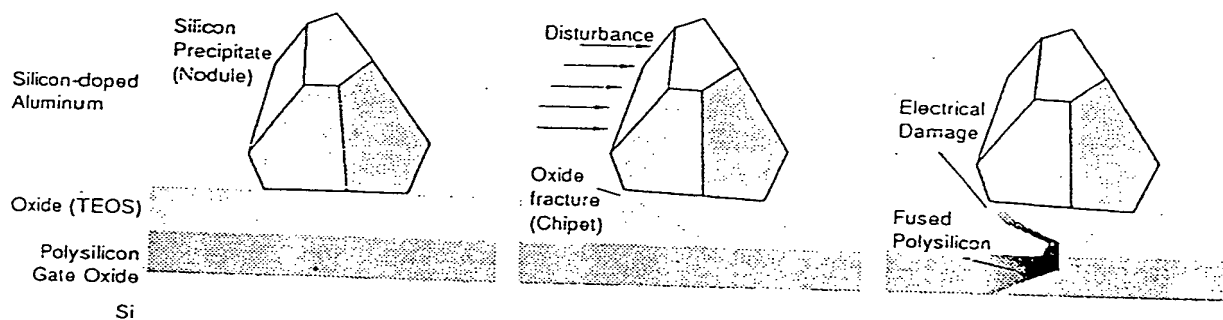
The adhered nodules could be removed quite easily; gentle brushing of a few fibers from a cotton swab was sufficient to disturb them. When these well-adhered nodules are displaced, they often take with them a portion of underlying oxide, forming a distinctive, football-shaped chip-out, or *chipet* (Figure 5). The depth of the resulting chipet was roughly equal to half the length of the chipet's minor axis, itself related to the area of contact between nodule and oxide.

In the MOSFET devices the lateral displacement of the nodules occurs during the wirebonding process. The cavity formed by the chipet is immediately filled with aluminum. These chipets, during

Figure 5: Movement of nodule results in fracture of underlying oxide.

electrical stress, appear to act as weak points in the insulating oxide. If the chipet is sufficiently deep to fully compromise the thickness of the dielectric oxide, a linear resistive short between the source metallization and gate polysilicon results. However, if the root only partially compromises the dielectric, a leaky diode-like characteristic results.
